# ENERGY EFFICIENT REHABILITATION OF A HISTORIC BUILDING IN TUCSON, ARIZONA: INVESTIGATING THE POTENTIAL FOR ENERGY CONSERVATION WHILE PRESERVING THE BUILDING'S HISTORICAL INTEGRITY

**Abstract.** The focus of this study was to investigate the feasibility of transforming historically significant buildings with high energy requirements into high-performance constructions. The researcher suggested adaptive reuse for the case study, recommending that the building be converted from a warehouse into a café and art studio, which would be in line with the surrounding art district in Tucson, Arizona. As a result of the change in design, everything from the floor plans to the building facades and the mechanical systems were modified. During the visit to the location, the researcher was able to identify the primary factors that led to the low energy efficiency. The study was conducted using the real-life energy simulation that the DOE-2 simulation engine provides. During the process of redesigning the building, the researcher utilized both passive and active design strategies to evaluate how these techniques impacted the amount of energy consumed by the structure. The total amount of energy

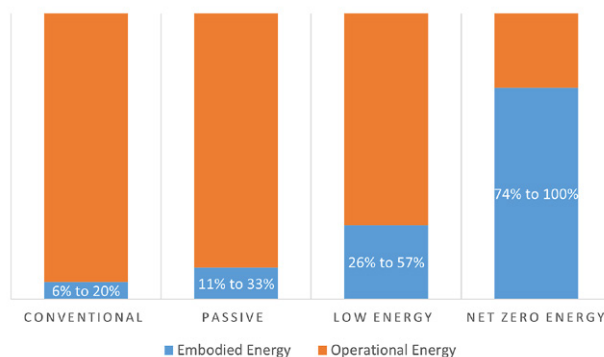
Figure 1. Illustration of the differences in embodied energy consumption corresponding to the building energy performance (Graph produced by: author; data source: Chastas et al., 2016)

Low-energy buildings are concepts for lowering overall energy consumption and CO<sub>2</sub> emissions in residential and commercial structures. After investigating 90 examples, Chastas et al. discovered that low-energy buildings consume more embodied energy than traditional structures (Figure 1) (Chastas et al., 2016). Sartori and Hestnes looked at 60 case studies of conventional and low-energy buildings, finding that embodied energy accounts for 2% to 38% of total energy usage in traditional buildings and 9% to 46% in low-energy buildings (Sartori & Hestnes, 2007). Building renovations combined with modern building technology give up a whole new world of possibilities for bettering building energy performance (Azari & Abbasabadi, 2018). The embodied energy of new construction is eliminated in the renovation of an existing structure. It is replaced by interventions embodied energy, which may be considerable or minor depending on the extent of the changes, materials, construction processes, and transportation.

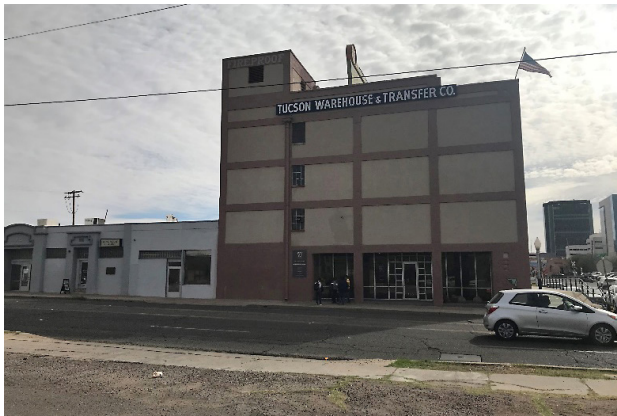
Figure 3. The north façade of the building (source: author)

It is a historic four-story concrete structure (Figures 3 and 4) at East Sixth Street and North Seventh Avenue in Tucson, Arizona, that is 91 years old. It used to be a storage facility with tiny administrative offices, but now it houses plumbing supplies, art galleries, and craftsmen businesses. The structure is located in the historic El Presidio area, where the majority of the structures date from 1860 to 1920. The city of Tucson was founded as a Spanish colonial colony from the El Presidio neighborhood. Sonoran style (1840s–1890), which is the oldest and most common in this neighborhood, Transformed Sonoran style (1880–1900), American Territorial (1880–1910), California Mission Revival (1895–1930), and Craftsman Bungalow Style (1905–1930) are among the architectural styles found in El Presidio (Nequette & Jeffery, 2021). This area is part of Tucson’s historic warehouse arts district, which includes a variety of art forms from the street to an art gallery with paintings and sculptures. The warehouse arts area has sprung up as a result of the downtown railroad’s 35-year renovation. After the Arizona Department of Transportation purchased numerous warehouse sites for destruction to develop a railroad-aligned with state highway in the late 1980s, the train attracted artists to this region.

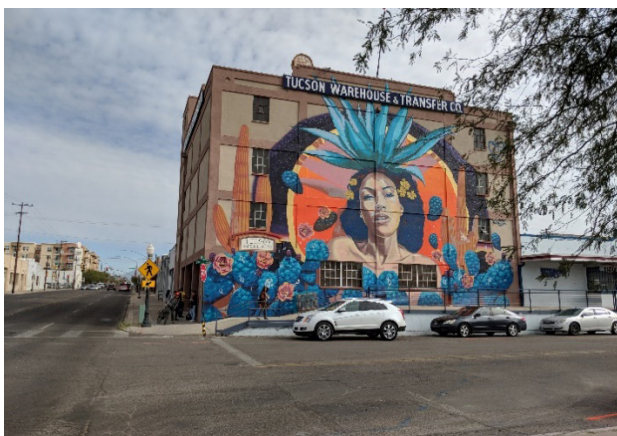
Figure 4. The west façade of the building showing the art wall (source: author)

A four-story concrete structure with a total built-up area of 16,176 ft. sq. is the subject of the case study. Art galleries and rentable offices (Figure 5) are now placed on the first level, while plumbing supplies (Figure 6) are housed in the one-story expansion structure that is not part of this study. A passageway on the southeast corner of the building links the structure to a plumbing supplies business. Contreras Gallery and Jewelry shared the east wall of the Tucson Warehouse building. The first-floor design, shown in Figure 7, illustrates the current floor arrangement as well as the positioning of structural components. The Skelton concrete system, which comprises of columns, beams, and a flat slab, was used to build the construction. For better structural stability and to distribute the load over a broader area of the flat slab, the structure system includes a drop panel and a column head. Currently, the second, third, and fourth levels remain unoccupied. Previously, they used as storage areas. The case study's façades are Beige and Burgundy colored cement mortar with clay bricks (Figure 4).

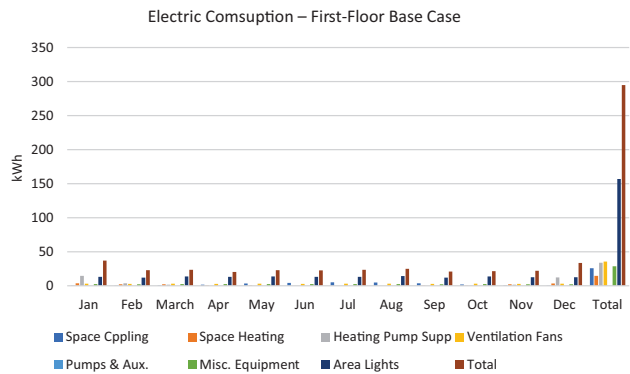
Figure 8. The result of the first-floor base case energy simulation

The researcher chose to develop an energy model for the existing condition as a baseline for the new design after pointing out the probable causes of low energy efficiency. The baseline energy model will come in handy to assess and evaluate the impact of the new design and intervention on energy efficiency. The energy simulation has taken into account the current situation, which is the utilization of just the first level (Figure 8). The yearly energy usage is calculated to be 294.88 kWh. The reuse, however, will apply to the entire structure, not just the first level. As a result, the researcher assumed that the reset floors would operate simultaneously and have the same mechanical and electrical systems as the first level. The rest of the floors were unconditioned and just had illumination because it was used for storage. The yearly energy usage of the entire structure is 352.14 kWh in the energy simulation (Figure 9).

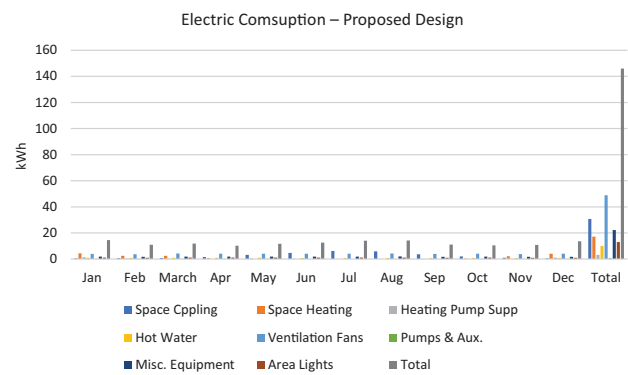
Figure 17. Energy simulation of the proposed design

The building envelope was improved, resulting in a tighter enclosure with a reduced infiltration rate. In this situation, the research assumed a 0.250 Air Change per Hour infiltration rate (ACH). With an economizer, the HVAC system replaced greater efficiency HVAC units with 21 Seasonal energy efficiency ratios (SEER). The HVAC operation schedule has a positive and negative

influence on energy usage. Except on holy days, the new timetable keeps the HVAC units running 24 hours a day. After typical working hours, the thermostat setting shifts from 74–75 degrees to 78 degrees. All artificial lighting has been replaced with LED lighting that uses 6 to 8 watts. The suggested design's energy modeling is an expansion of the base case model's data and parameters. The energy simulation result shows a 55 percent reduction in energy use compared to the baseline condition. The proposed design used 146.05 kWh per year (Figure 17).
